Re: Asbestos Contamination Assessment

On March 11, 2014 Churchill Environmental performed a Contamination Assessment at 68 Main St. Canajoharie, NY in Buildings 38, 45, and 57 due to the disturbance of Asbestos Aircell Pipe Insulation caused by the sub contractor M&M Consulting & Contracting out of Jersey City, New Jersey. The sub contractor was cutting out copper pipes, wiring, and steel. The assessment was performed by Ray Churchill, a certified USEPA/NYSDOL Building Inspector/Project Monitor and Project Designer.

Beechnut Incidental Disturbance Areas

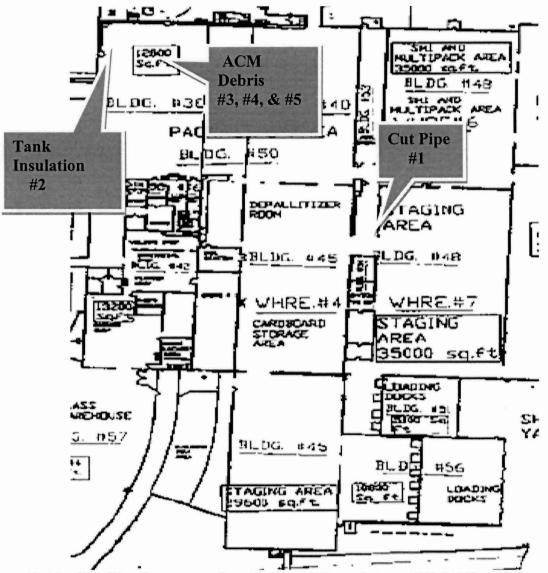
In Building 54, the Pedestrian Walkway a pipe with ACM Aircell under the roof rafters was cut with one end falling to the floor, the other end stayed suspended. The visual inspection found approximately 4' of debris where the pipe dragged after hitting the floor. Four TEM Micro-Vac Samples were taken approximately 15' out from the pipe to see if any asbestos fibers had migrated outward from the pipe. Of the four samples, one had two ACM Chrysotile Fibers in it. The Micro-Vac's were taken using a 100cm squared template and a low-vol pump running at 2 L/M for two minutes. Based on this finding the Contaminated area was moved back another 15' feet from that sample. That entire section of the hallway is considered contaminated. This is Incidental Disturbance #1. See the attached lab results, floor plans, and photos.

- 1). Aircell on Pipe that was cut from Ceiling-Walkway between #45 & #48 = $\overline{1,000}$ sq. ft.
- 2). Tank Insulation NW Corner-Matrix Insulation on Pipe broke down = 8 sq. ft.
- 3). Scattered Debris on Floor where Concrete Deck cut down = 2,100 sq. ft.

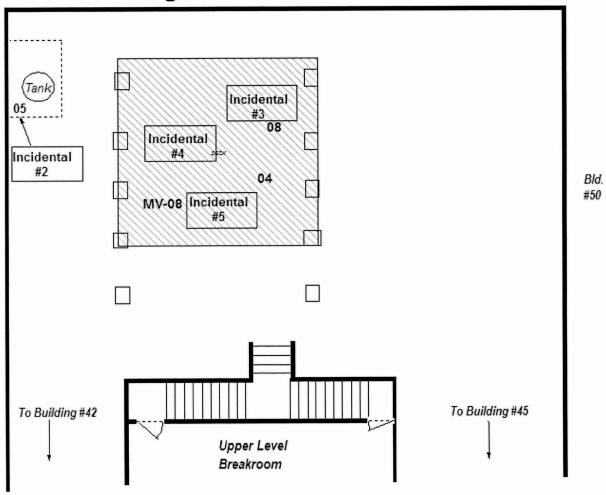
Building 38 Incidental Disturbances

Building #38 has two separate Incidental Disturbances, one is next to a tank in the N.W. Corner by the Yellow Railing and the other is across from that where what use to be an elevated concrete deck was taken down by the workers from M&M Contractors in order to get the steel beams for scrap.

The Disturbance where the Concrete Deck was cut down covers approximately a 30'x 70' area. ACM Debris from the pipes above in the ceiling was found and one Micro-Vac Sample had 1 Chrysotile Fiber in it. The other Micro-Vac's did not have any asbestos in them. The Contaminated Area was determined based on the Visual Inspection, Bulk Samples, and Micro-Vac Samples taken. Where the last seen suspected ACM was seen the area was taken out an additional 1' in each direction. This is Incidental Disturbance #3, #4, and #5.

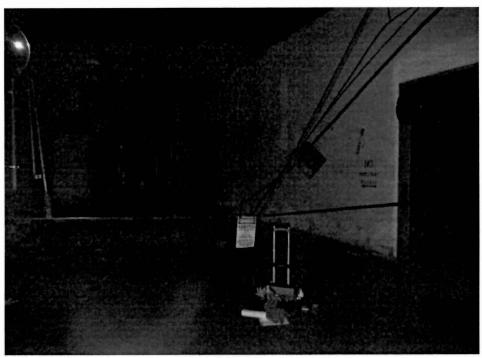
The Cut ACM Pipe in the Walkway

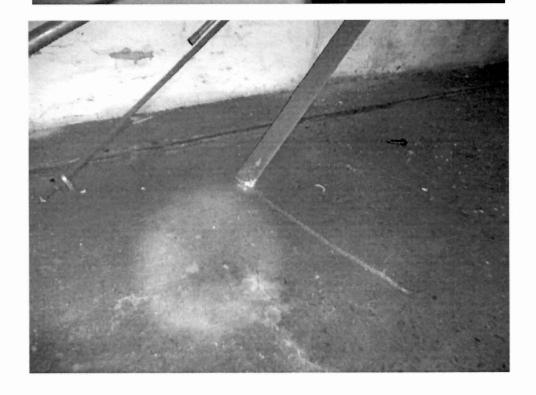
The Tank Disturbance is due to the Matrix of the Pipe Insulation breaking down. There is only 12"-18" of pipe that was on this pipe where it goes into the concrete floor. This is a Minor Disturbance and should have the floor and wall cleaned 2' out from the wall and 4' down from the pipe in each direction along the wall. This is Incidental Disturbance #2

Incidental #2 by the Tank in the NW Corner of Building 38

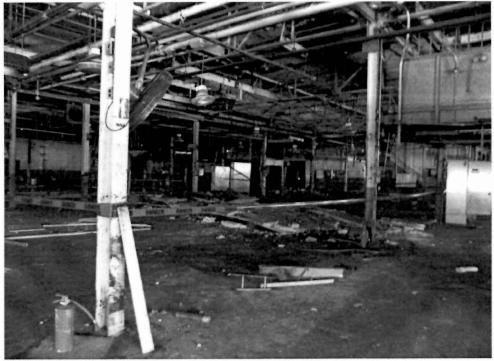
The Damaged Aircell from the removal of the Upper Concrete Deck
